Pressman's Toolbox

Getting rid of tension headaches

By Frank Bourlon

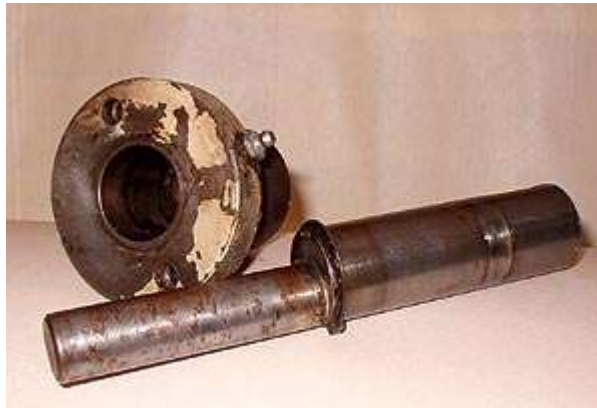
The problem may be the eccentric shaft and eccentric shaft sleeve (see Figure 1).

Fig. 1: Eccentric shaft and sleeve.

The eccentric sleeve is undercut in the middle so that the eccentric shaft is supported on both ends of the sleeve (one-half inch support on the drive side of the sleeve and three-quarter inch support on the operator side of the sleeve).

The reason for this variance is to enable less friction between the dancer and the brake shoe and also to hold grease for lubrication purposes.

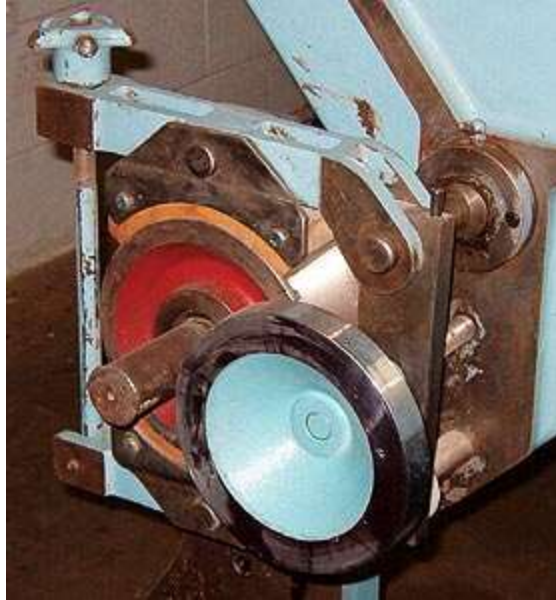
Figure 2 shows the complete brake assembly of a Goss Community press and Figure 3 shows the eccentric shaft and sleeve in the frame with the brake shoe removed.

Fig. 2: Community brake assembly.

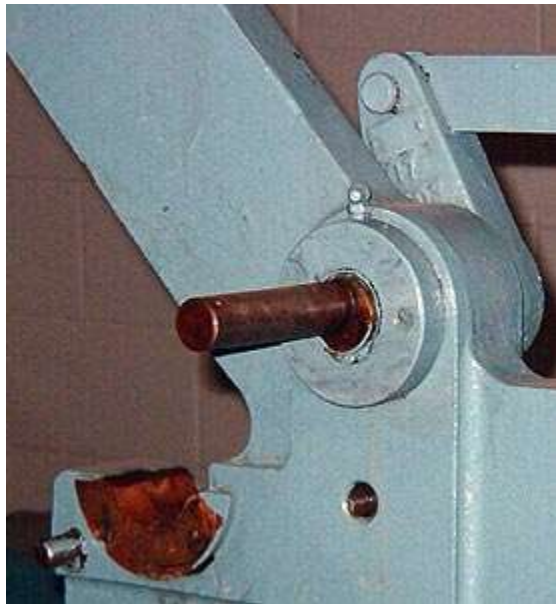
Fig. 3: Eccentric shaft and sleeve with shoe removed.

The eccentric shaft can be removed by first removing the brake shoes. This is done by turning the sidelay hand wheel counter-clockwise until

the brake shoe assembly is off of the eccentric shaft. When the brake shoe is removed, the assembly will resemble Figure 3.

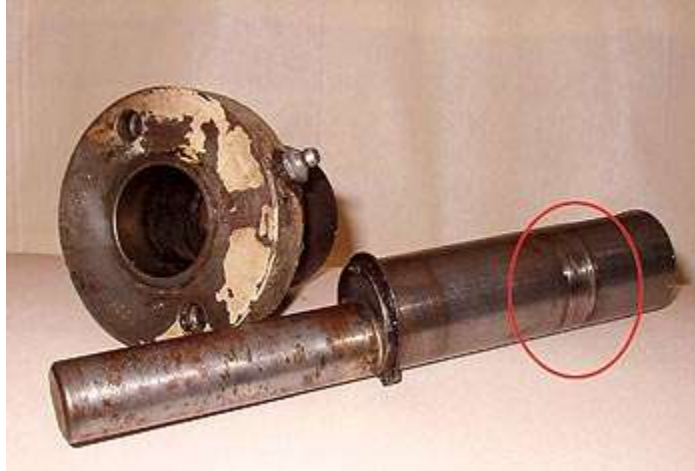
Examine the wear on the eccentric shaft in Figure 4. This wear is normally caused by lack of grease or deterioration over time.

Fig. 4: Wear on eccentric shaft.

The excessive wear on the eccentric shaft and the eccentric sleeve causes a lateral movement of the eccentric shaft along with its designed rotational movement. The lateral movement causes the eccentric shaft to bind and then release, which causes the dancer to swing wildly, thus causing loss of web tension and poor print register control.

You can inspect the eccentric shaft for wear by grabbing the eccentric shaft and the eccentric shaft lever (which is on the opposite side of the frame) and trying to rock the assembly back and forth. The eccentric shaft and sleeve should be replaced if any movement in the lateral direction is noticed.

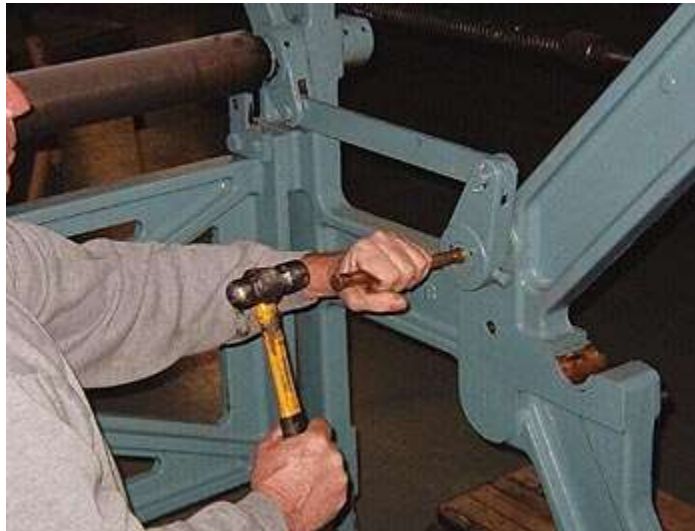
Next, the eccentric lever pin must be removed to allow easier access. At this point, the eccentric shaft can be removed from the eccentric lever by loosening the bolts that hold the eccentric shaft lever to the eccentric shaft, then driving the eccentric shaft from the drive side of the press (see Figure 5).

Fig. 5: Removing the shaft.

Once the shaft is removed, the sleeve can be detached by removing the two hex bolts from the eccentric sleeve and then driving the eccentric shaft from the unit frame in the same manner as removing the eccentric shaft.

To replace the components, reverse the removal process. It should take about an hour to complete the repair.
